Implementation of solar cell booster to prevent damage to the electrical system and overcome CA N'T-Start Problems on PC2000-8 Units at PT PPA Jobsite Borneo Indobara

Margono^a, Suryana^b, Sugiyanto^c, Arly Fiesnanda Baven Putra^d

Keywords: Solar cell, Electrical System PC 2000-8, PT Putra Perkasa Abadi

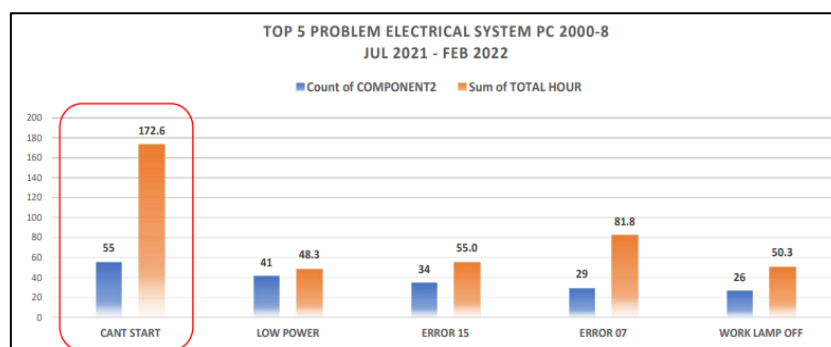
Figure 5
Top 5 PC 2000-8 Electrical System Problems for July 2021 – February 2022

In the TOP 5 data of electrical damage to the PC2000-8 system above (Figure 5), the problem of *can't start* is the main trend of unscheduled breakdown in the unit. It was noted that the frequency and downtime experienced 55 times the damage with a total time of 172.6 hours. To deal with the electrical problems of the engine can't start system on the PC2000-8, PT Putra Perkasa Abadi carried out improvements with the theme of Implementation of Solar cell *Booster to Prevent Damage to the Electrical System and Overcome Can't Start Problems on the PC2000-8 Unit at PT PPA Jobsite Borneo Indobara.*

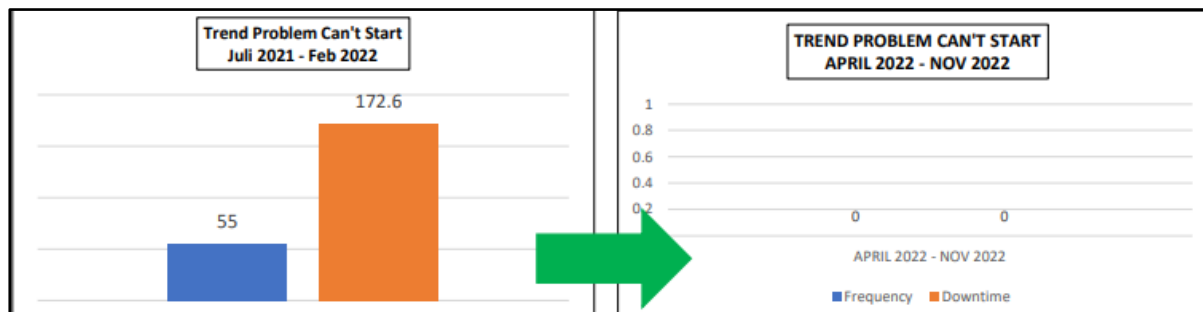
Figure 14

Before the installation of the improved solar cell on the PC2000-8 unit, it was known that in the period July 2021 – February 2022, the frequency of breakdown of the unscheduled electrical system can't start was 55 times with a downtime of 172.6 hours. Then after the installation of the solar cell improvement, it is known that based on the dispatcher data record for April 2022 – November 2022 is zero (0) frequency and zero (0) hours of downtime or no breakdown of the unscheduled electrical system, can't start again.
