Implementation of solar cell booster to prevent damage to the electrical system and overcome CA N'T-Start Problems on PC2000-8 Units at PT PPA Jobsite Borneo Indobara

Margono^a, Suryana^b, Sugiyanto^c, Arly Fiesnanda Baven Putra^d

Keywords: Solar cell, Electrical System PC 2000-8, PT Putra Perkasa Abadi

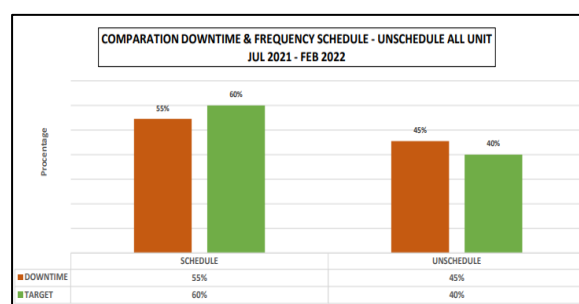
Figure 1

Comparison Downtime & Frequency Schedule – Unschedule All Units July 2021 – February 2022

Comparison of breakdown schedule and unscheduled data from July 2021 to February 2022: Downtime 55%: 44% not by the KPI target, namely schedule 60% and unscheduled 40% (Figure 2).

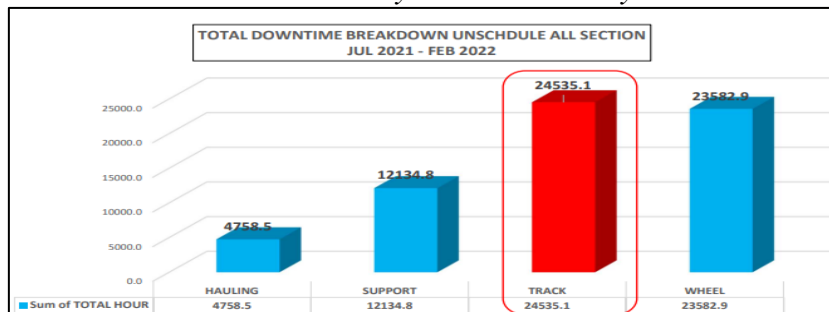
Figure 2

Total Breakdown Unschedule All Section July 2021 – February 2022

The mapping results of each section show that the highest unscheduled breakdown is in the track section, which is 24535 hours, so the main target for improvement steps is units in the track section (Figure 3).

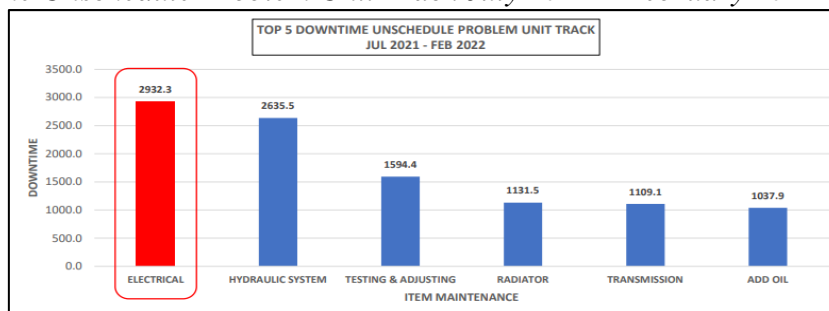
Figure 3

Top 5 Downtime Unschedule Problem Unit Track July 2021 – February 2022

The specification of unscheduled unit track breakdown data shows that the highest component downtime problem is electrical as much as 2932.3 hours, so electrical problems are the main target for improvement (Figure 4).

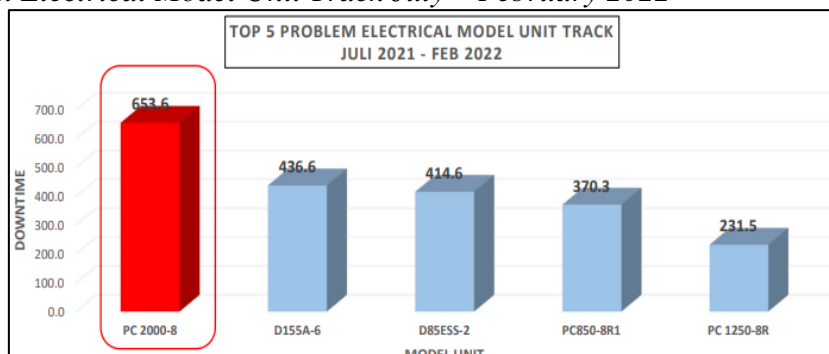
Figure 4

Top 5 Problem Electrical Model Unit Track July – February 2022

Based on the graph above, it is known that the electrical damage trend specifications are based on the unit model. The first highest damage was the PC2000-8 unit with a downtime of 653.6 hours, so repairs were focused on the unit.

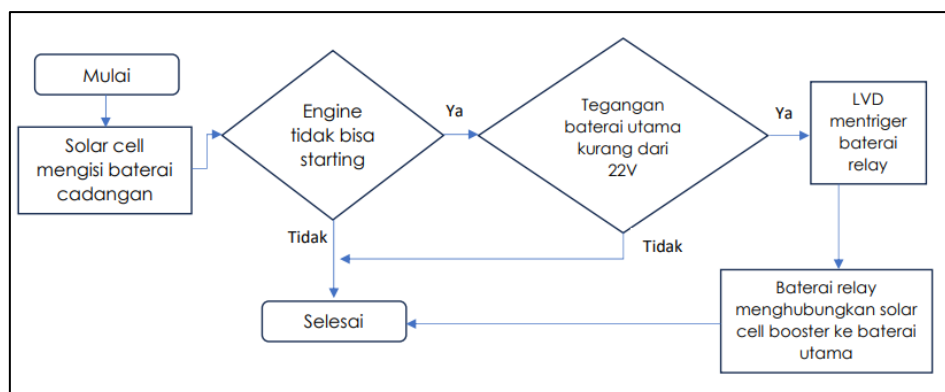
Figure 6
 Solar Cell Working Process Flow Diagram

To overcome the problem of breakdown unscheduled electrical system can't start, PT Putra Perkasa Abadi developed an improvement in the addition of solar cells to the PC2000-8 unit through a scheme of procuring a backup power source on the unit so that if there is an abnormality in the alternator charging system or a decrease in the voltage of the unit's main battery, the solar cell will automatically help supply electricity or booster an existing main battery. The improvement was chosen because the installation of solar cells can anticipate and overcome potential problems related to electricity in the PC2000-8 unit. In addition, other supporting activities can be implemented to support the success of the improvement, namely through the installation of stickers prohibiting the use of electricity when the unit is off and adding a battery voltage indicator on the panel screen. The implementation of these improvements is expected to prevent and reduce the frequency or breakdown time of unscheduled electrical engine can't start problems due to low battery voltage (Figure 6).

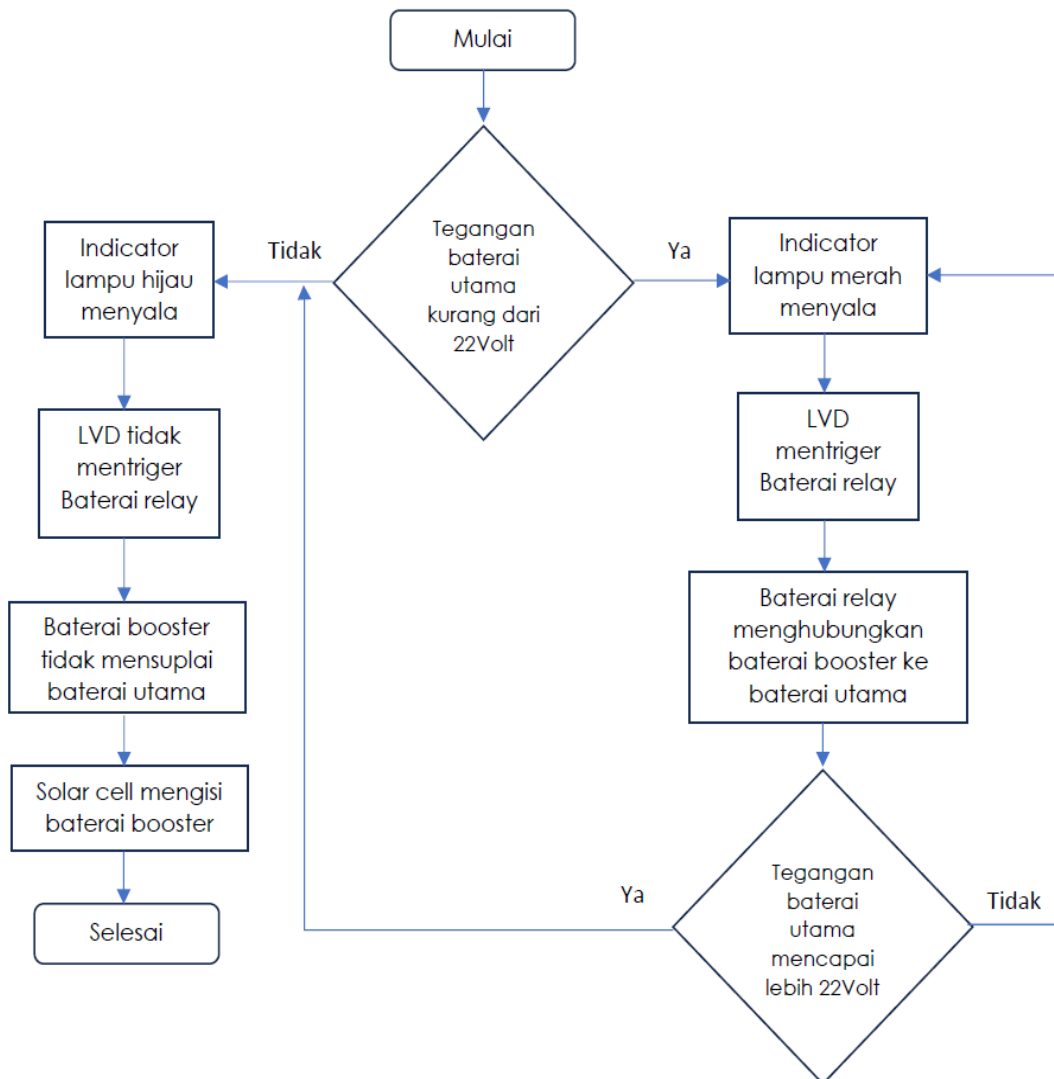
Figure 9

Solar Cell Booster Working Flow Diagram

- Under normal conditions when the unit battery has a voltage of more than 22 Volts, the electric current in the booster battery is not connected to the unit battery, automatically the indicator light will display green and the solar panel will charge the booster battery because the LVD trigger is set at a voltage of less than 22 volts.
- When the battery condition of the unit is abnormal or the voltage is less than 22 volts, the indicator light will change to red. LVD will activate the battery relay to pass electric current from the booster battery to the main battery of the unit. This lasts until the unit's battery voltage again reaches more than 22 volts. When the voltage has reached more than 22 volts, the indicator light will again turn green. LVD will trigger the battery relay again to cut off the electric current from the *solar cell booster battery* to the unit battery.

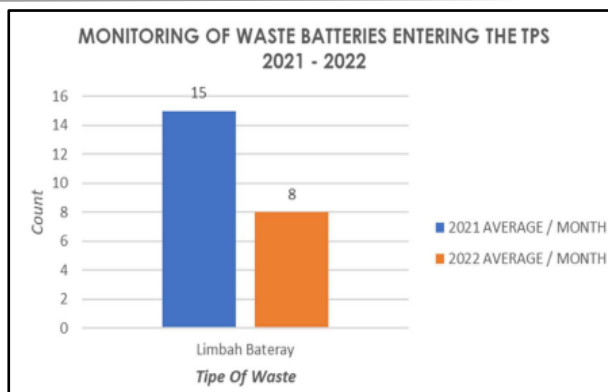
Figure 15

Monitoring Waste Battery Entering the TPS 2021 – 2022

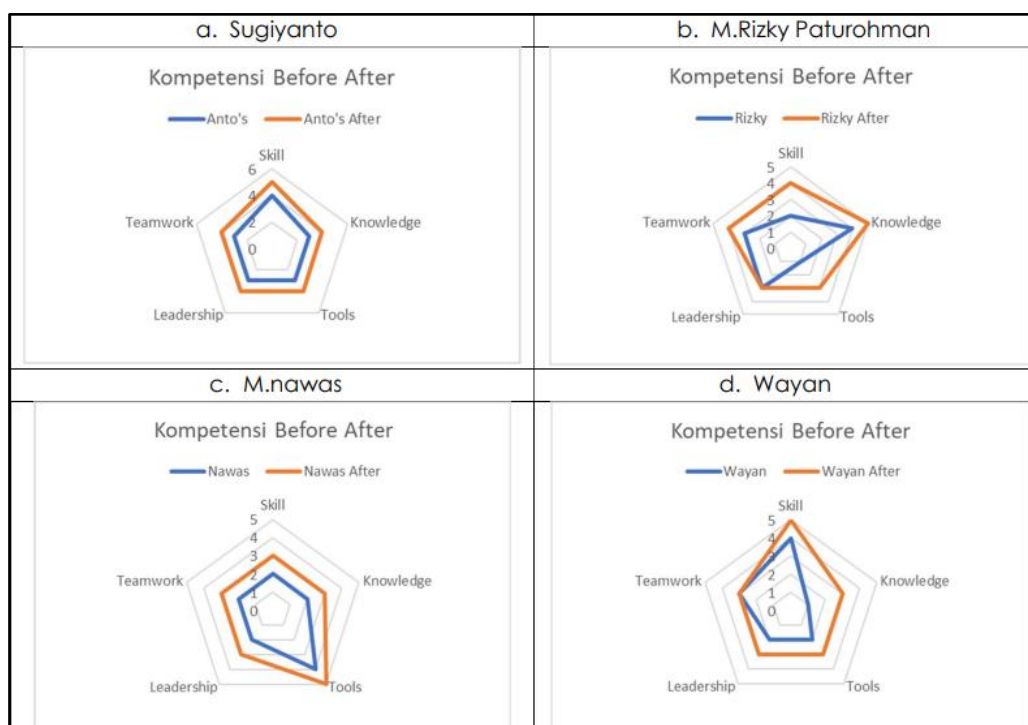
Figure 16
 Team Member Competencies Before and After the Implementation of Improvement Solar Cell Booster
